Subject: Tag Lane Dairy Farm, April 27, 2017 U.S. EPA Clean Water Act Inspection Report; WI-0063932-01-0

## WPDES Permit and Nutrient Management Plan Inspection and File Audit U.S. ENVIRONMENTAL PROTECTION AGENCY, REGION 5

On April 27, 2017, EPA followed up on a citizen complaint that alleged that Tag Lane Dairy Farm was discharging process wastewater from their abandoned vegetated treatment area (VTA) that discharges through a culvert under River Valley Road into an unnamed tributary that flows to the Rock River. The weather was overcast and raining.

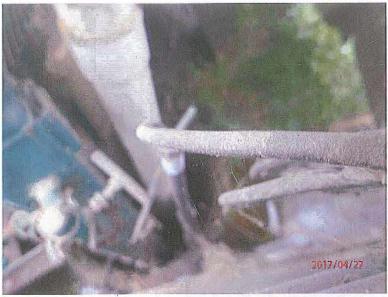
Photograph: (P427001) Observing the collection pump.

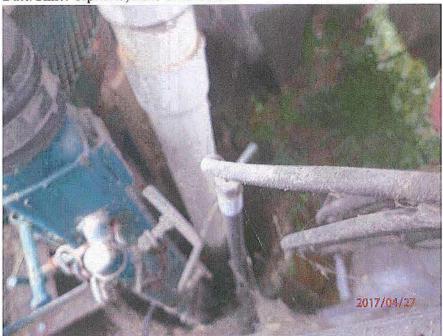
Photograph:(P4270002) Looking down to verify water is below pump level.

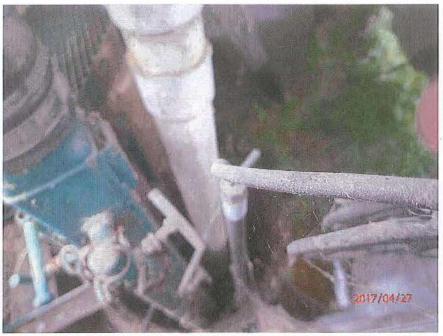
Photograph: (P4270003) Collection pump - verifying level of water in collection pump.

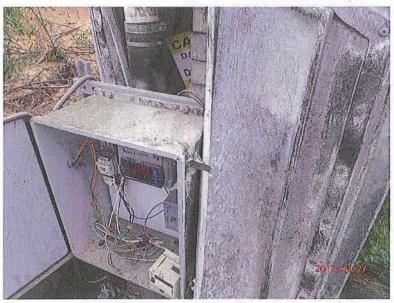
Photograph: (P4270004) Electrical box for pump that collects process wastewater off the feed storage area. Documents amount of flow, so Tag Lane Dairy Farm can record when the level is more than the pump can handle and results in an overflow.

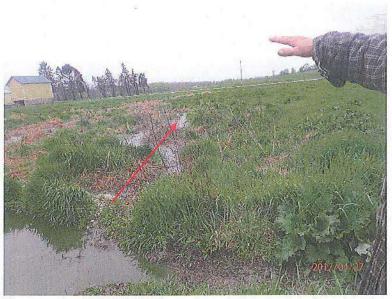
Photograph: (P4270005) Flows through the vegetated treatment area (red arrow illustrates flow direction).

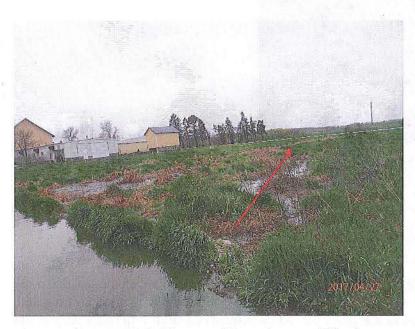
Photograph: (P4270006) Close up of the pathways within the vegetated treatment area (red arrow

illustrates flow direction).

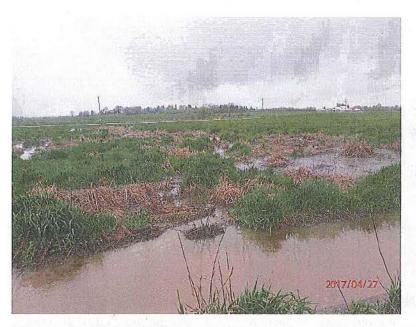
Photograph: (PA4270007) This trench was used to collect process wastewater from the feed pad prior to October 18, 2016. Since, the installation of the interim measures installed October 18, 2016, it is now collecting storm water that is being dispersed through the VTA.

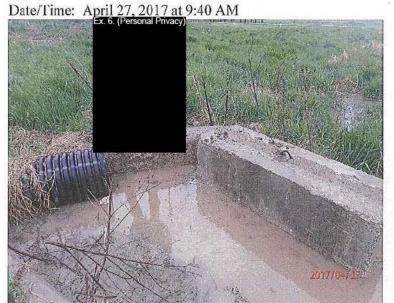
Photograph: (PA4270008) Culvert that flows into collection area prior to going through the separation bar and into the vegetated treatment area. Originally designed to collect excess process wastewater from the silage feed pad area after a certain amount was collected and discharged into WSF 1, the remaining would gravity flow into the vegetated treatment area. The VTA has now been abandoned. At the time of the inspection, no flow was coming out of culvert.
